# ROUTE 109 CORRIDOR STUDY

July 11, 2017

## FINAL REPORT

Prepared for:  
MaineDOT  
Maine Turnpike Authority  
Town of Wells

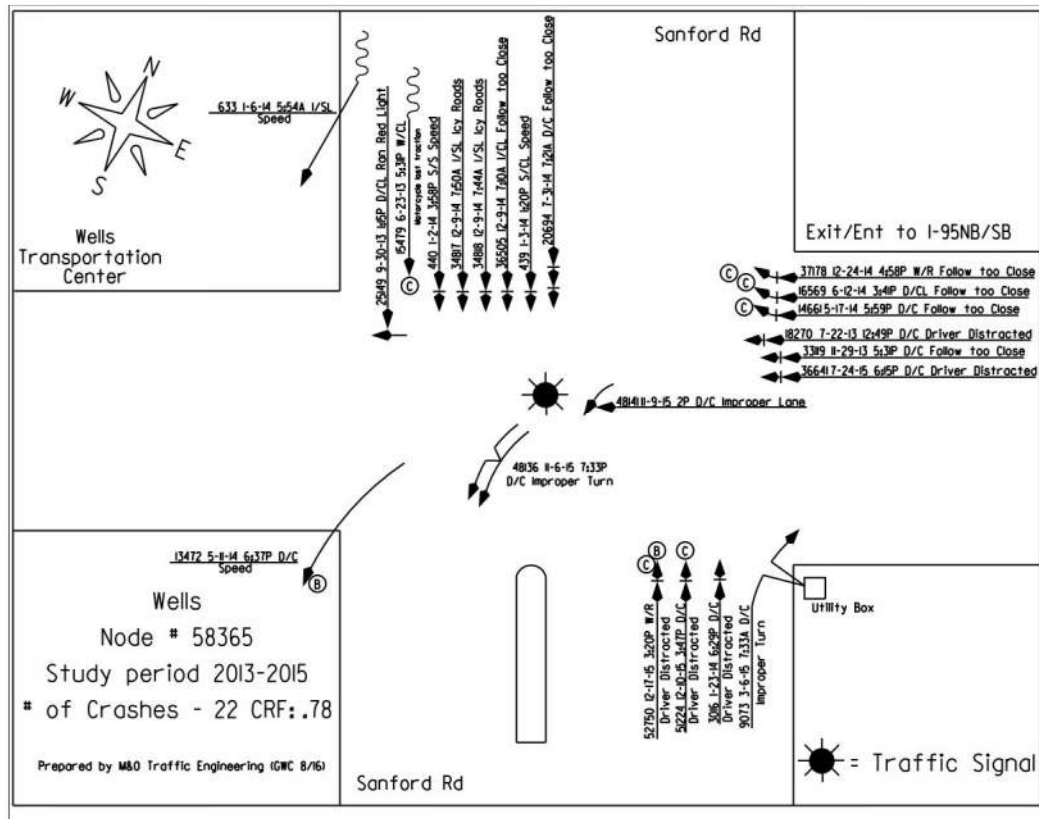
FIGURE 13: COLLISION DIAGRAM FOR ROUTES 109 & 9 (SANFORD ROAD) AND MTA EXIT 19/WELLS TRANSPORTATION CENTER

While not an HCL (the CRF was less than 1), the intersection of Routes 109 and 9 (Sanford Road) and Maine Turnpike Exit 19/Wells Transportation Center has a high number of crashes – 22. **Figure 13** indicates traveling east and west on Routes 109 & 9 (Sanford Road), the majority of crashes are related to rear-end collisions where drivers were following too closely, speeding, or distracted. Exiting the Turnpike, drivers rear-ended others

making the right turn from the Turnpike Exit 19 approach onto Routes 109 and 9 westbound and going straight through the intersection to the Wells Transportation Center. These crashes were caused by vehicles following too closely and drivers who were distracted. There are no discernable patterns in relation to driver characteristics, types of vehicles, or day of the week. Ten of the 22 crashes occurred during the winter months of December and January. There were 2 crashes with minor injuries and 4 crashes with a possible injury, the remainder of crashes were property damage only. All collision diagrams were provided by MaineDOT.

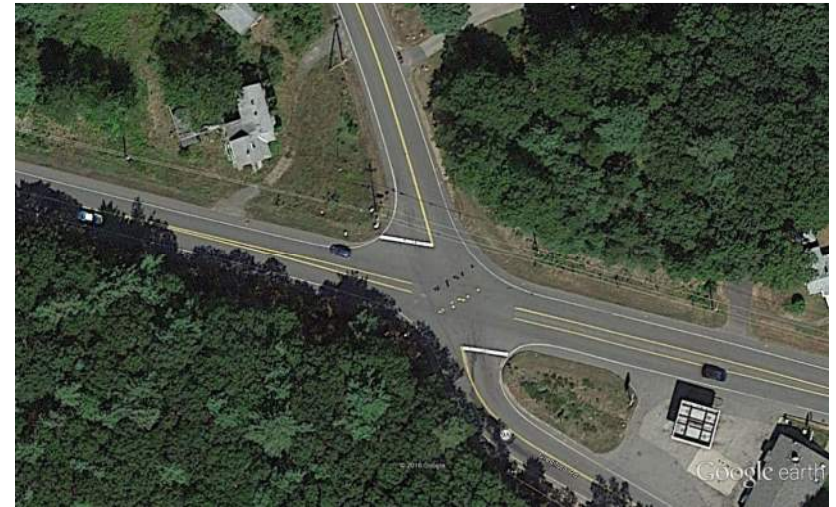
**FIGURE 14: INTERSECTION OF ROUTE 109 (SANFORD ROAD) AND BRANCH ROAD/CREDIFORD ROAD**

**Figure 14** depicts the four leg intersection with single lane approaches with flashing yellow and red signals. Lane widths on Route 109 are approximately 11½ feet with 7 foot shoulders west of the intersection and 6 foot shoulders east of the intersection. Side road lane widths are approximately 12-13 feet in width with negligible shoulders.

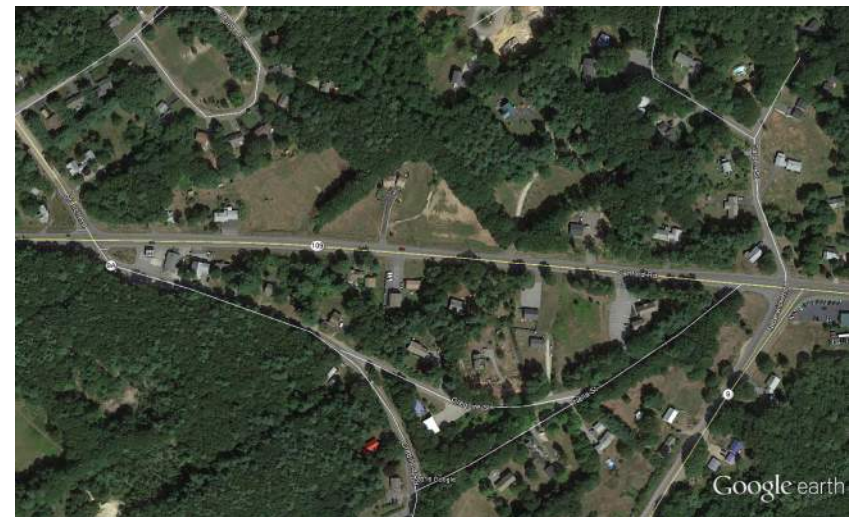
**FIGURE 15: SEGMENT OF ROUTE 109 (SANFORD ROAD) BETWEEN BRANCH ROAD/CREDIFORD ROAD AND ROUTE 9 (NORTH BERWICK ROAD)/GARDEN STREET**

**Figure 15** depicts the two lane section with a mixture of business and residential use. Lanes are approximately 11½ feet wide with varying 6-7 foot shoulders. The regulatory speed limit is 40mph.

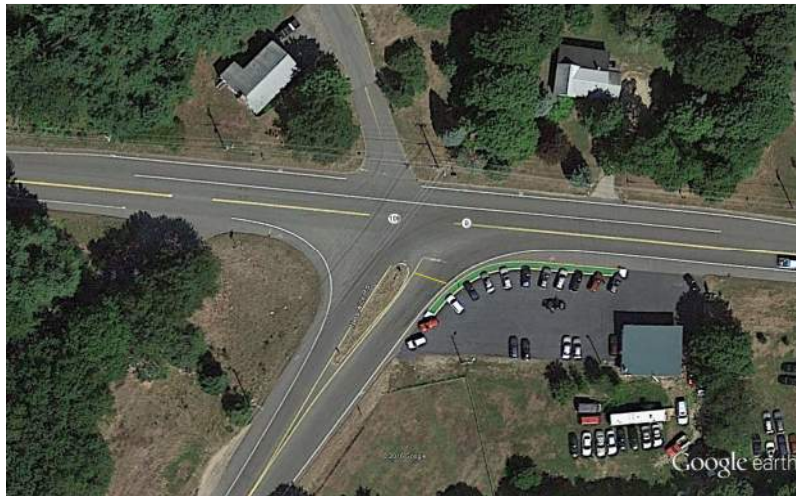
**FIGURE 16: INTERSECTION OF ROUTE 109 (SANFORD ROAD) AND ROUTE 9 (NORTH BERWICK ROAD)/GARDEN STREET**

**Figure 16** depicts the four-leg intersection with single lane approaches and a short westbound left-turn bypass lane. Lane widths on Route 109 are approximately 12 feet with negligible westbound shoulders and approximately 6 foot shoulders eastbound. Garden Street is approximately 26 feet wide and is stop controlled with no marked shoulders and Route 9 is approximately 12 feet wide before the intersection and up to more than 20 feet wide at the stop bar.

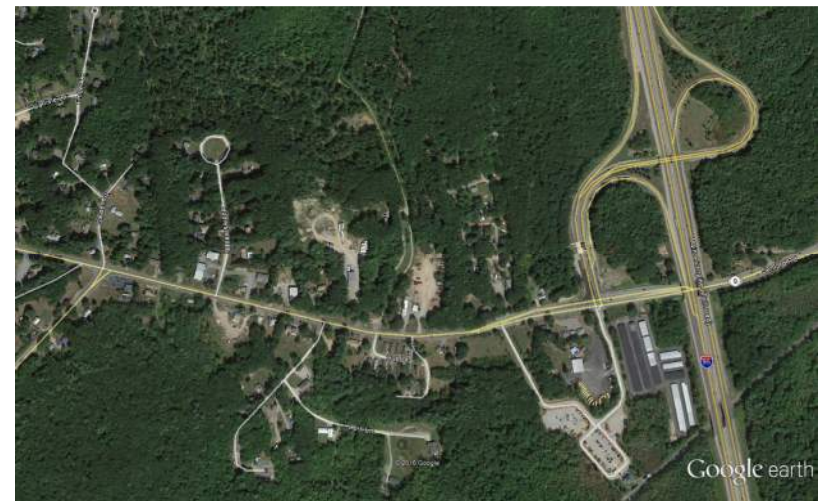
**Figure 17** depicts the segment of Route 109 which widens at the approach with the intersection at the Turnpike Exit 19. This is a two lane section with a mixture of business and residential land uses. Lanes are approximately 12 feet wide with varying 7-8 foot shoulders. From Hubbard Lane to Garden Street, the speed limit is 40 mph; from Hubbard Lane to the Transportation Center, the speed limit is 35 mph. In addition, there is a lane drop westbound departing the Turnpike Exit 19 Intersection.

**FIGURE 17: SEGMENT OF ROUTE 109 (SANFORD ROAD) BETWEEN ROUTE 9 (NORTH BERWICK ROAD)/GARDEN STREET AND MTA EXIT 19/WELLS TRANSPORTATION CENTER**

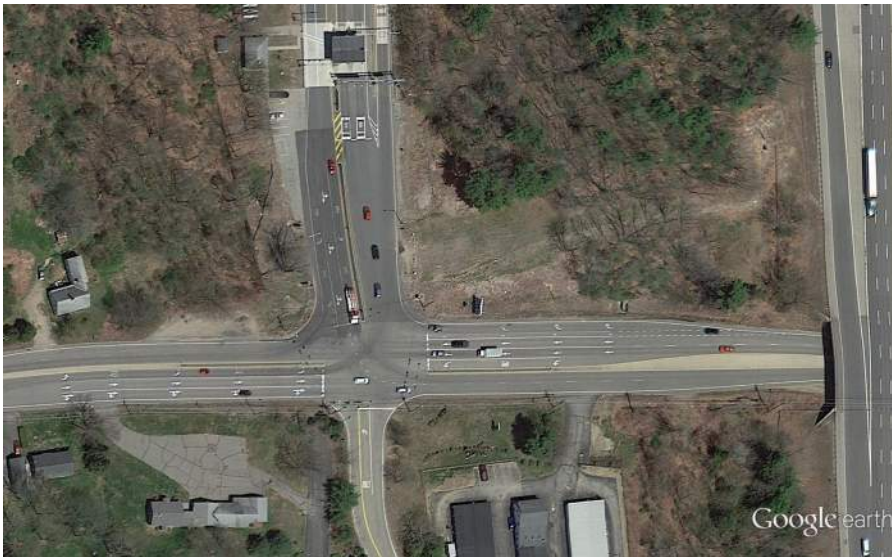
**Figure 18** depicts the four leg intersection with multi-lane signalized approaches. The MTA approach is three lanes with a left, combined through/left, and right lane configuration. The northbound Wells Transportation Center has a left lane and a combined through/right lane. These two approaches operate as split traffic signal phases due to the double left turn lane from the Turnpike Exit 19 approach. Westbound on Route 109 there is a left, two through lanes and a right lane approach. Eastbound on Route 109 there is a left, through, and through/right lane configuration approach. Eastbound and westbound receiving lanes both have a two lane configuration that drops to one lane downstream of the intersection.

**FIGURE 18: INTERSECTION OF ROUTE 109 AND 9 (SANFORD ROAD) AND MTA EXIT 19/WELLS TRANSPORTATION CENTER**

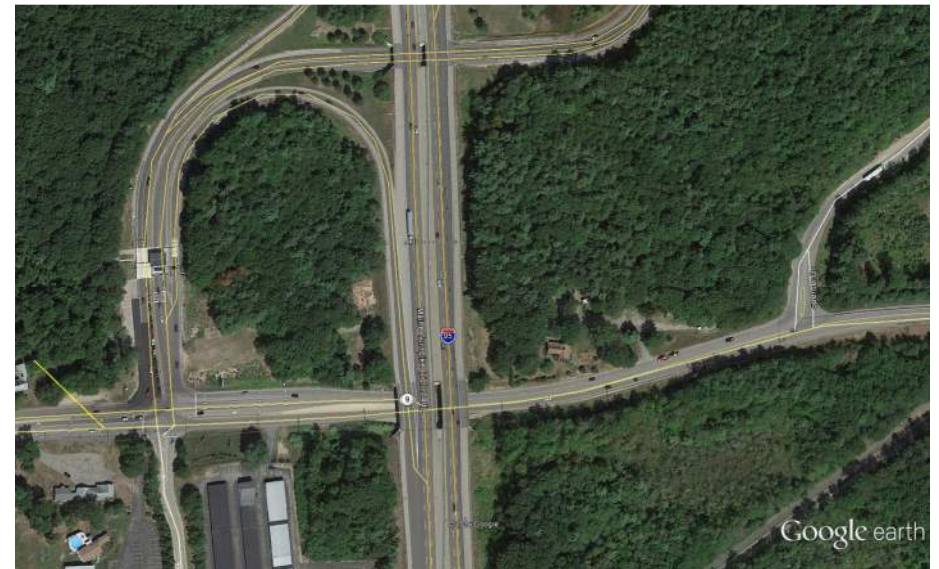
**Figure 19** depicts that westbound Route 109 is a 12 foot two-lane section of road with 1-2 foot shoulders. Eastbound Route 109 has a one lane section of road with 0-5 foot shoulders. This segment has a regulatory speed limit of 35 mph. There is a lane drop eastbound just after the intersection that stops prior to the Turnpike bridges.

**FIGURE 19: SEGMENT OF ROUTE 109 AND 9 (SANFORD ROAD) BETWEEN MTA EXIT 19/WELLS TRANSPORTATION CENTER AND SPENCER DRIVE**

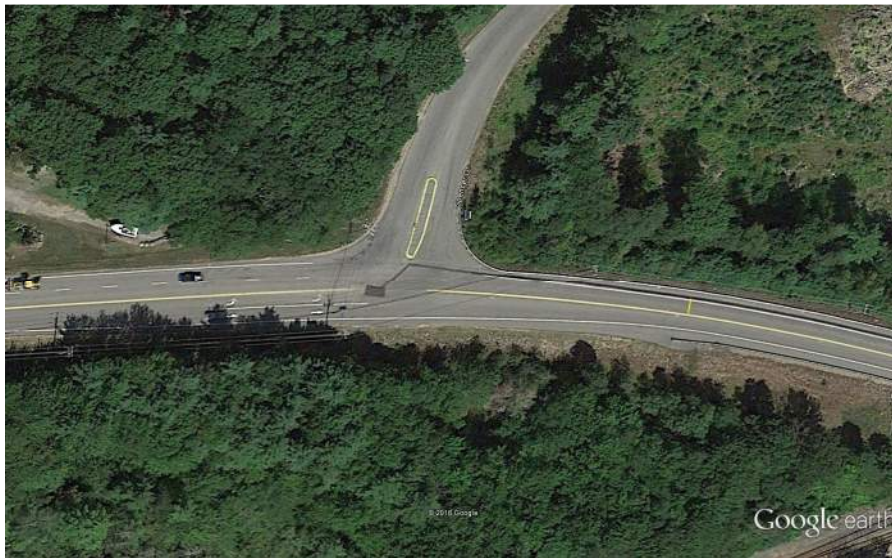
**Figure 20** depicts this is a three-leg intersection. The intersection is stop controlled on Spencer Drive and operates free-flow on Route 109. West of the intersection there are two departure lanes and two approach lanes: a left and through lane. Lanes are approximately 12 feet wide with minimal shoulders and steep slopes east of the intersection.

**FIGURE 20: INTERSECTION OF ROUTE 109 & 9 (SANFORD ROAD) AND SPENCER DRIVE**

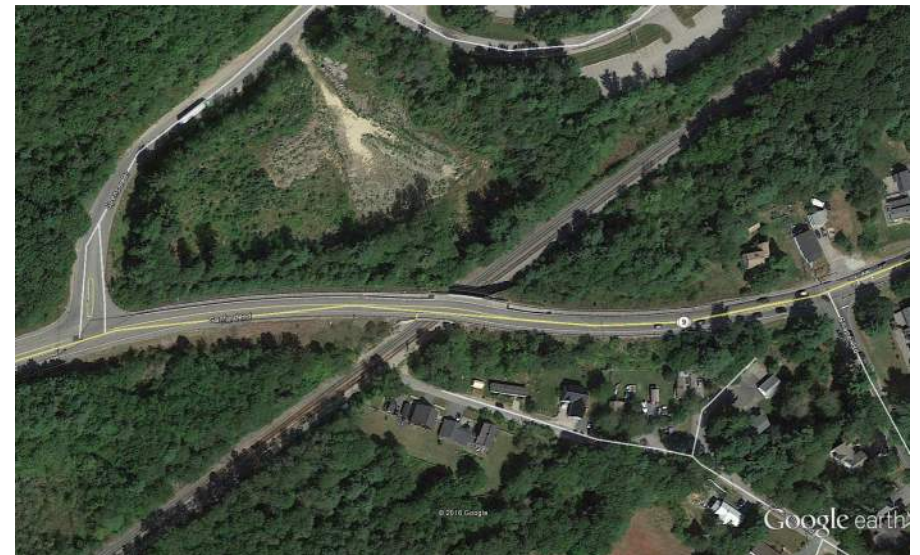
**Figure 21** depicts the two-lane section with little development. This section contains a bridge that crosses over the B&O Railroad tracks. Lanes are approximately 12 feet in width with 9 foot shoulders. This segment of road has a regulatory speed limit of 35 mph.

**FIGURE 21: SEGMENT OF ROUTE 109 & 9 (SANFORD ROAD) BETWEEN SPENCER DRIVE AND CHAPEL ROAD**

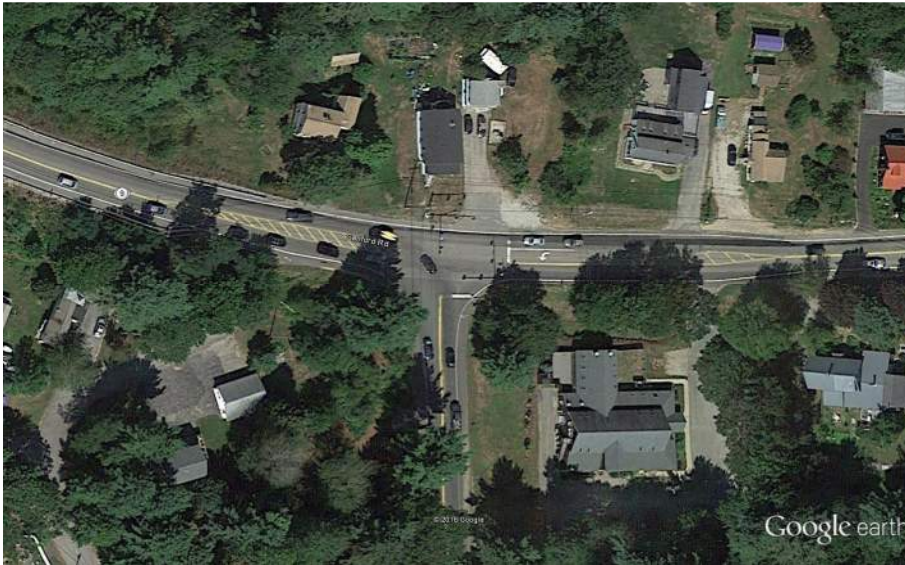
Figure 22 depicts the signalized three-leg intersection. East of the intersection there are two approach lanes, a left and through lane. All other legs are single lane approaches and receiving lanes. Lanes are approximately 12 feet wide with minimal shoulders.

FIGURE 22: INTERSECTION OF ROUTE 109 & 9 (SANFORD ROAD) AND CHAPEL ROAD

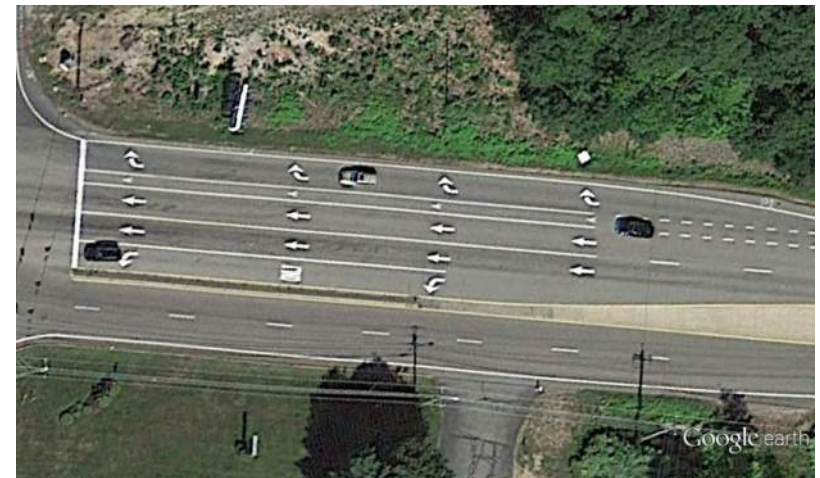
Figure 23 depicts the only marked bicycle facility in the corridor. There are no connecting facilities on either side of the intersection. Throughout the rest of the corridor, shoulders are the only other type of facility available, and not all are wide enough for safe bicycle use.

FIGURE 23: EXAMPLE OF STRIPED BICYCLE FACILITIES (AT MTA INTERSECTION)

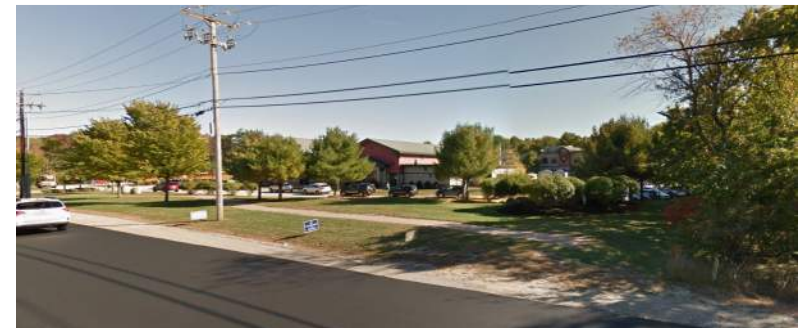
While there are currently no sidewalks or crosswalks in the corridor, the Wells Sidewalk Plan proposes a 5-foot sidewalk from the intersection with Wells Transportation Center to Route 1. The existing sidewalk on Route 109 (at the Wells Elementary School) is shown in Figure 24, which is about 0.9 miles from the Turnpike Exit 19 intersection, just to the east of Chapel Road. Curbing is largely granite.

FIGURE 24: EXISTING SIDEWALK INFRASTRUCTURE OUTSIDE THE STUDY AREA

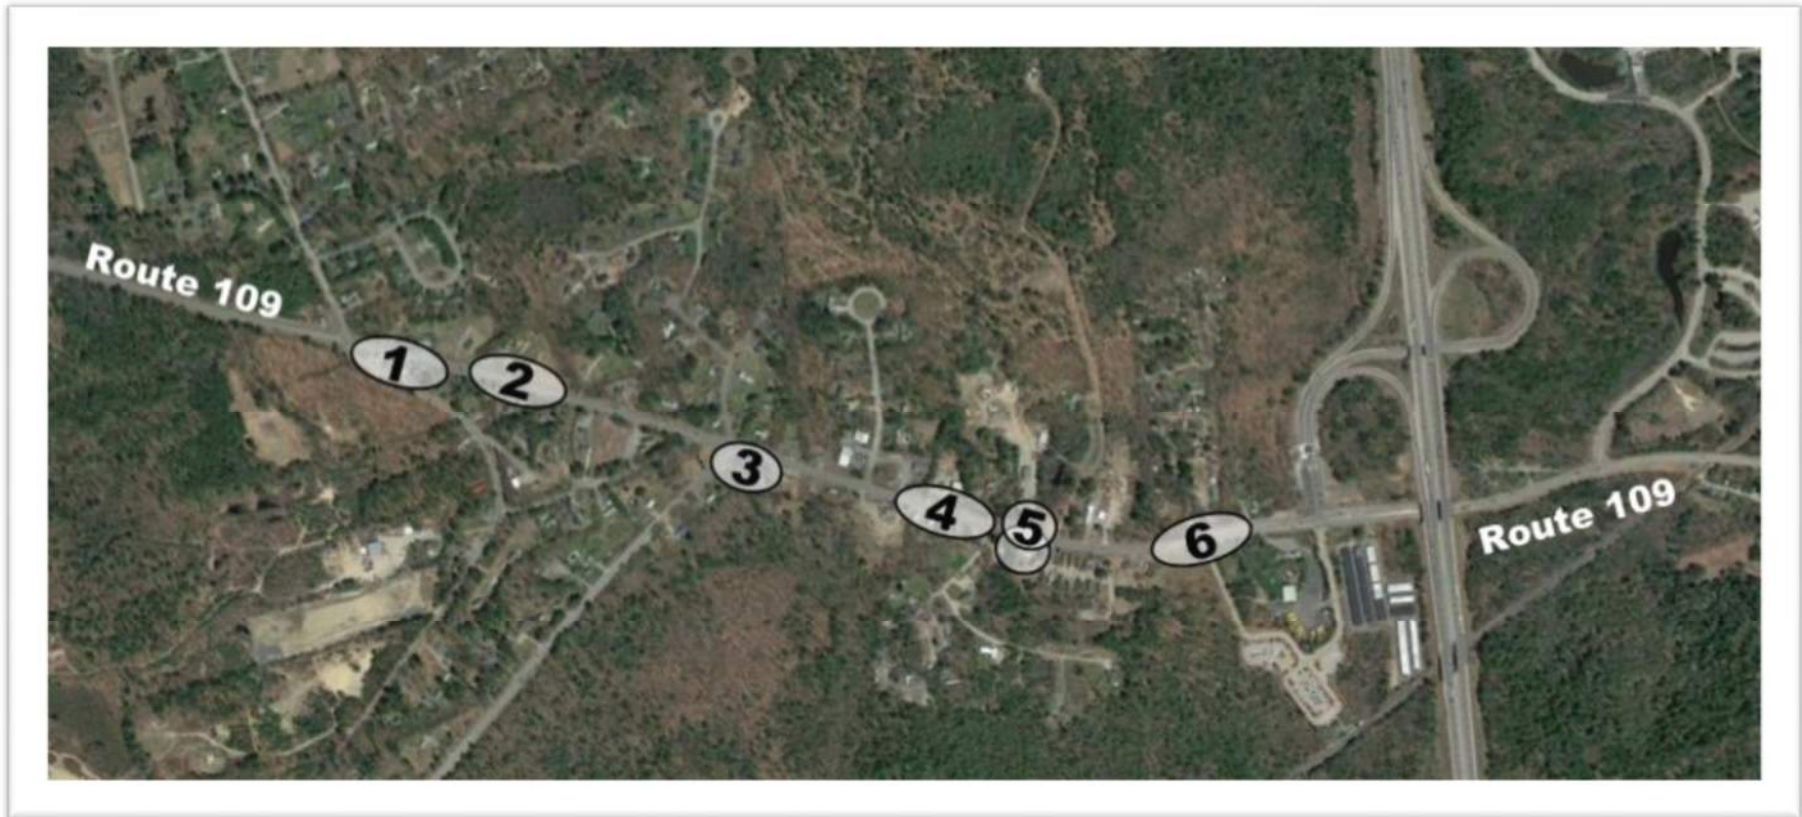
Several location in the corridor do not meet the previously mentioned access management standards. The locations are provided below, in **Figure 28**.

**FIGURE 28: ACCESS MANAGEMENT DEFICIENCY LOCATIONS**

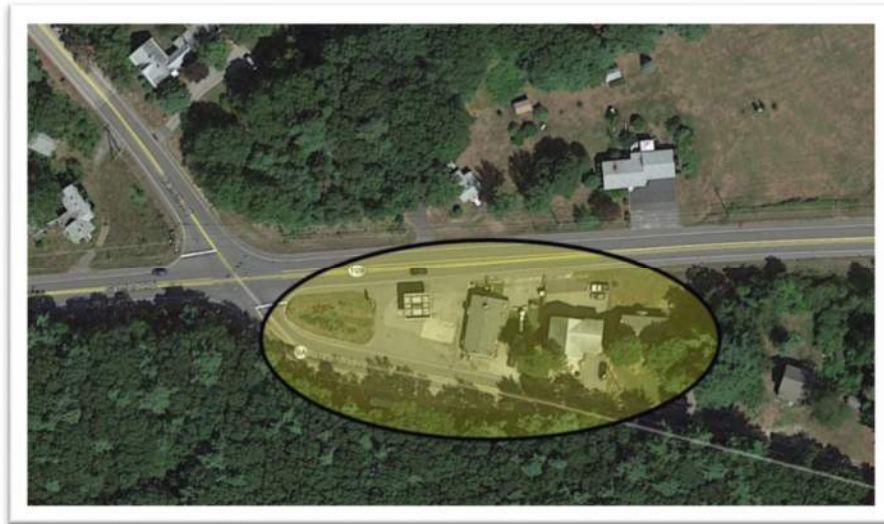
Location 1, represented by **Figure 29** (a gas station and apartment building), does not meet access management standards for the number of driveways, corner clearance or location of drives on Route 109.

**FIGURE 29: ACCESS MANAGEMENT DEFICIENCIES AT INTERSECTION OF ROUTE 109 (SANFORD ROAD) AND BRANCH ROAD/CREDIFORD ROAD**

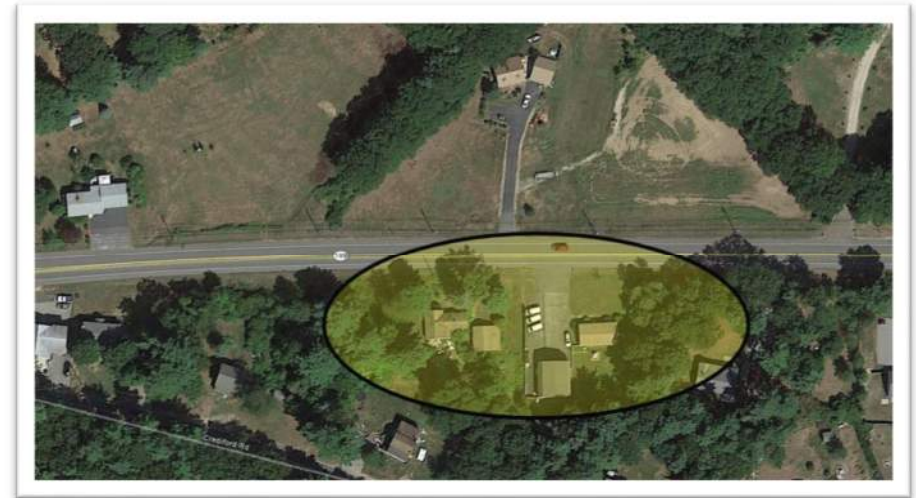
Location 2, represented on **Figure 30**, depicts driveways that do not meet driveway spacing standards.

**FIGURE 30: ACCESS MANAGEMENT DEFICIENCIES ALONG ROUTE 109 (SANFORD ROAD) BETWEEN INTERSECTION WITH BRANCH ROAD/CREDIFORD ROAD AND ROUTE 9 (NORTH BERWICK ROAD)/GARDEN STREET**

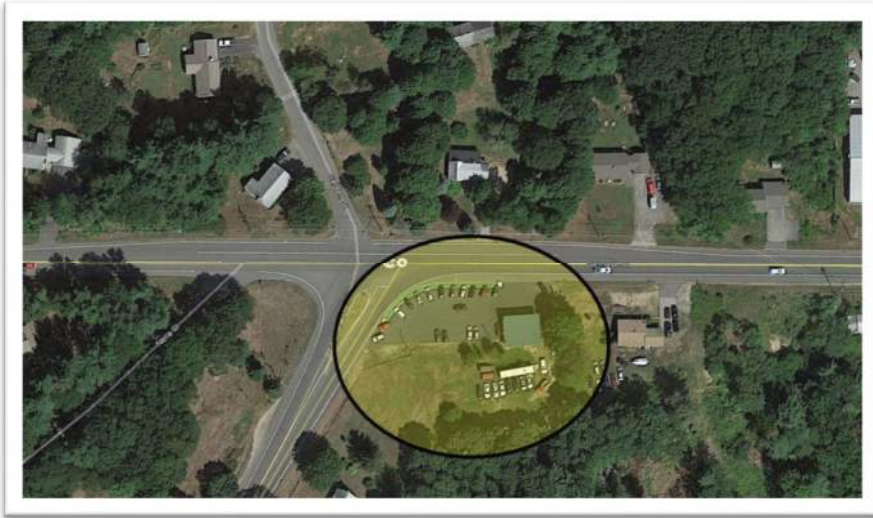
Location 3, represented on **Figure 31**, depicts driveways to a parking lot that does not meet minimum corner clearance requirements.

**FIGURE 31: ACCESS MANAGEMENT DEFICIENCIES AT INTERSECTION OF ROUTE 109 (SANFORD ROAD) AND ROUTE 9 (NORTH BERWICK ROAD)/GARDEN STREET**

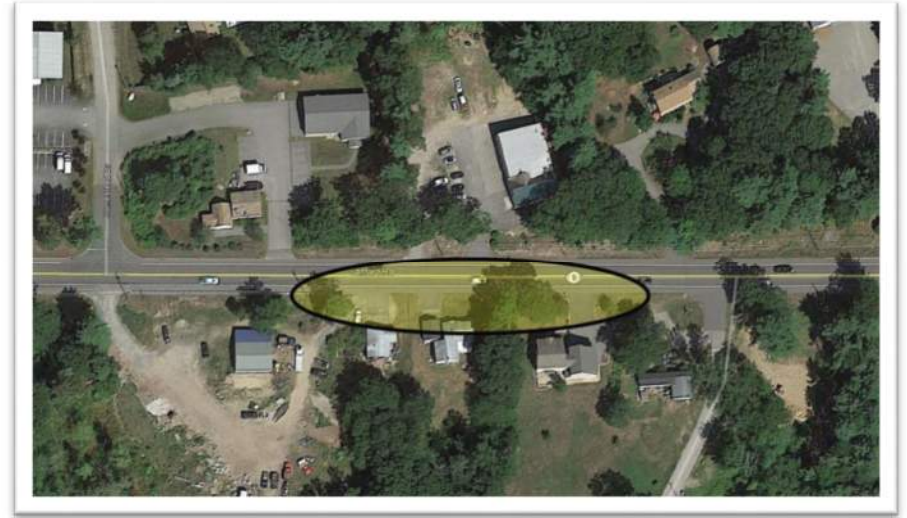
Location 4, represented on **Figure 32**, depicts driveways along Route 109 (Sanford Road) that do not meet spacing requirements.

**FIGURE 32: ACCESS MANAGEMENT DEFICIENCIES ALONG ROUTE 109 (SANFORD ROAD) BETWEEN INTERSECTION WITH ROUTE 9 (NORTH BERWICK ROAD)/GARDEN STREET AND MTA EXIT 19/WELLS TRANSPORTATION CENTER**

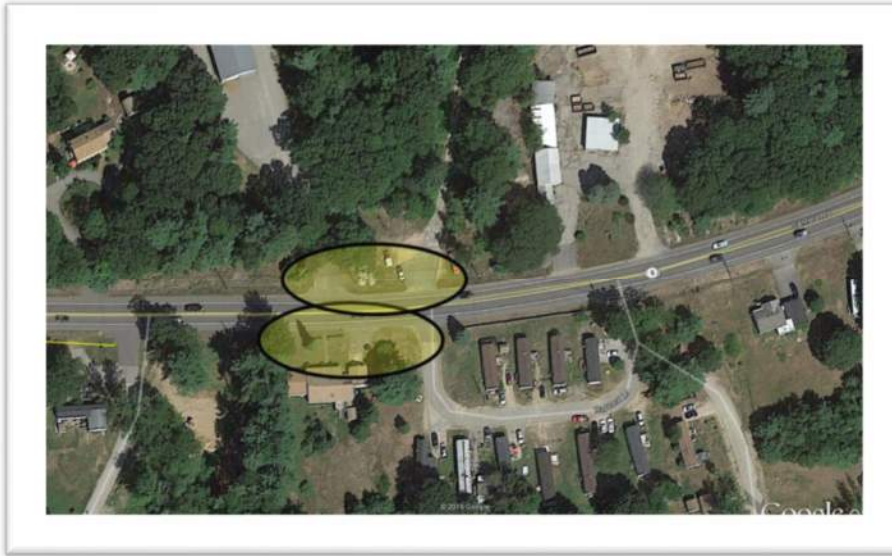
Location 5, represented on **Figure 33**, depicts driveways along Route 109 near Hubbard Lane. The drives to the north and south of Route 109 do not meet driveway spacing requirements.

**FIGURE 33: ACCESS MANAGEMENT DEFICIENCIES ALONG ROUTES 109 & 9 (SANFORD ROAD) BETWEEN INTERSECTION WITH MTA EXIT 19/WELLS TRANSPORTATION CENTER AND SPENCER DRIVE**

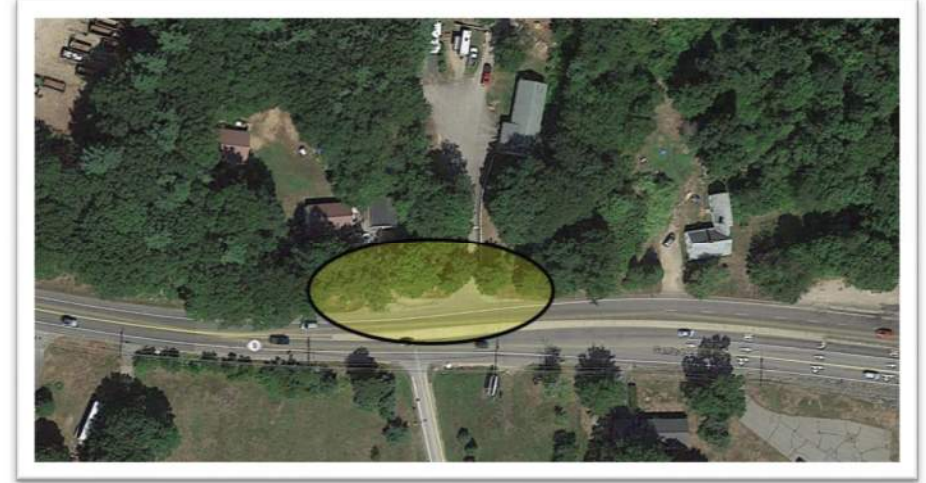
Location 6, represented on **Figure 34**, depicts driveways across from the westerly entrance to the Transportation Center. These driveways do not meet spacing requirements.

**FIGURE 34: ACCESS MANAGEMENT DEFICIENCIES ALONG ROUTE 109 & 9 (SANFORD ROAD) BETWEEN INTERSECTION WITH SPENCER DRIVE AND CHAPEL ROAD**

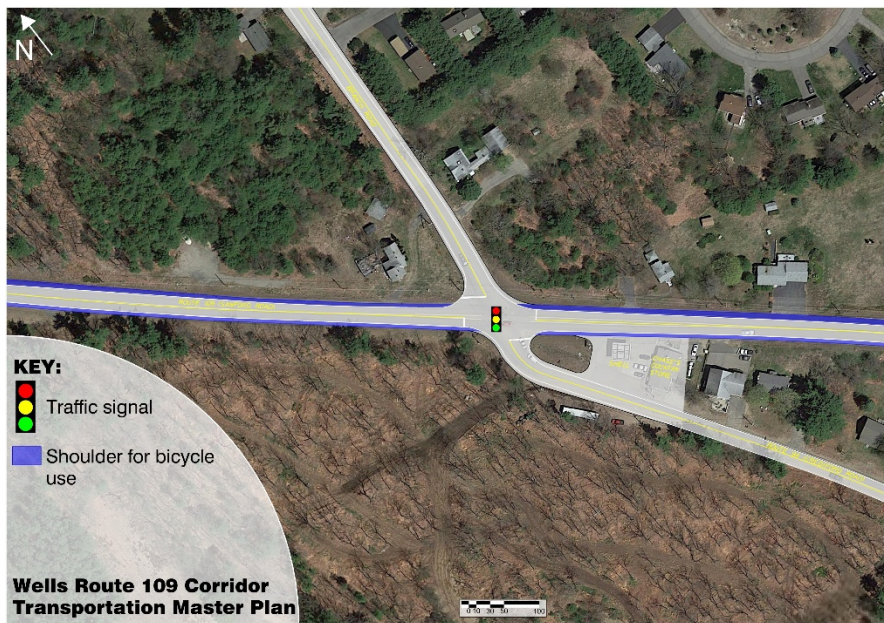
It is recommended that a traffic signal be installed at the subject intersection. No geometric improvements are recommended. **Figure 37** illustrates the proposed improvements.

Figure 37: Proposed Improvement to the Intersection of Route 109 (Sanford Road) and Branch Road/Crediford Road

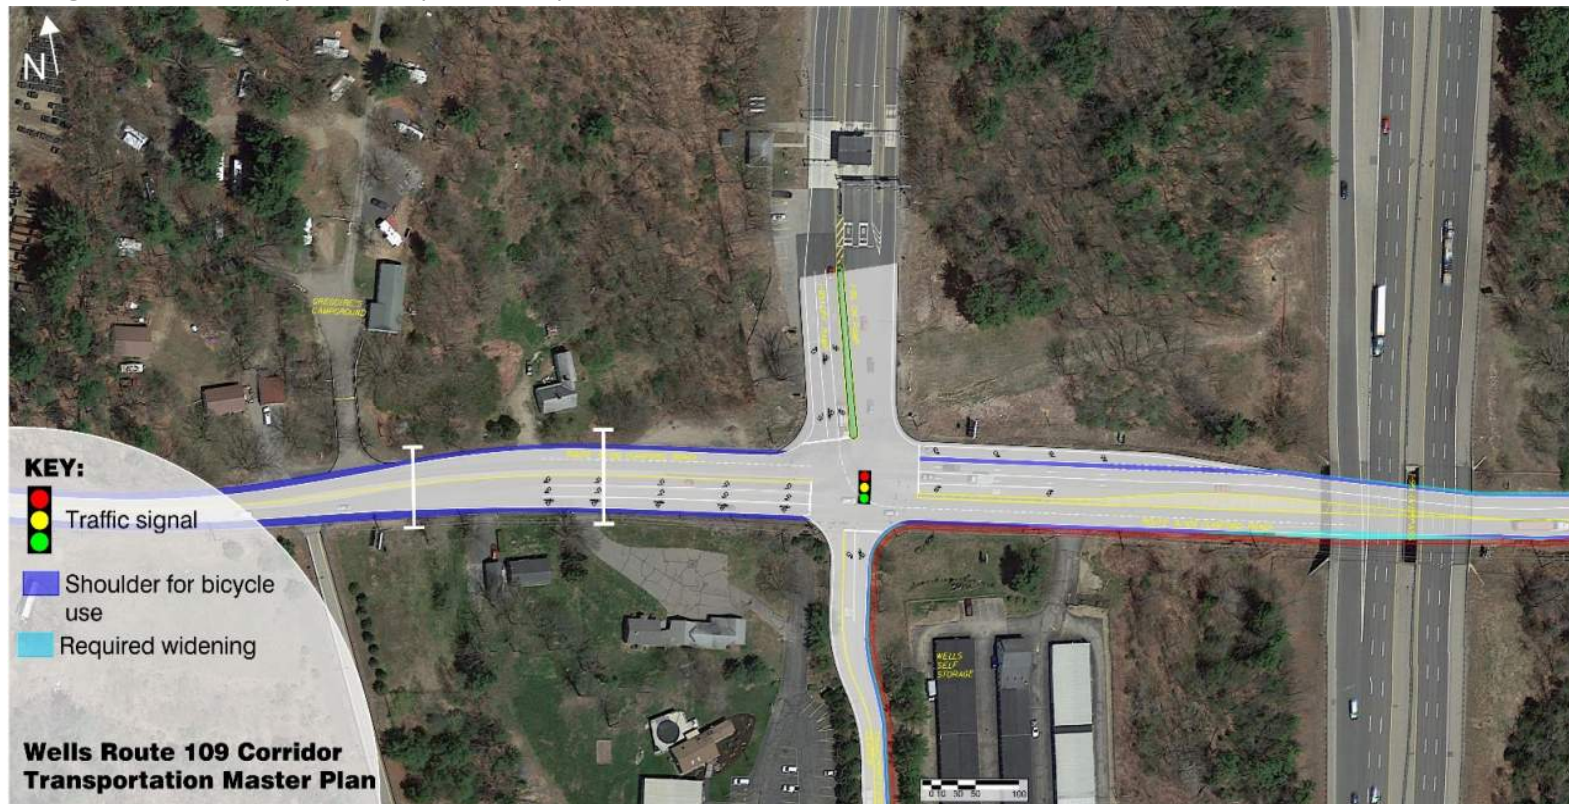
Several recommendations have been made for this intersection, as shown in **Figure 39**. These recommendations include:

- Modification of the existing signal to adaptive control
- Modification of eastbound Route 109 approach to a double left and through-right approach – turn bays are to remain approximately 300 ft long, which will satisfy 2036 95<sup>th</sup> percentile queue estimates
- Installation of two overhead lane assignment signage structures
- Extend the two eastbound departure lanes after the intersection by 250 feet before the lane drop occurs. (Approximately at the Turnpike bridges.)

Figure 39: Recommended Improvements for the Intersection of Routes 109 and 9 (Sanford Road) and Turnpike Exit 19/Wells Transportation Center

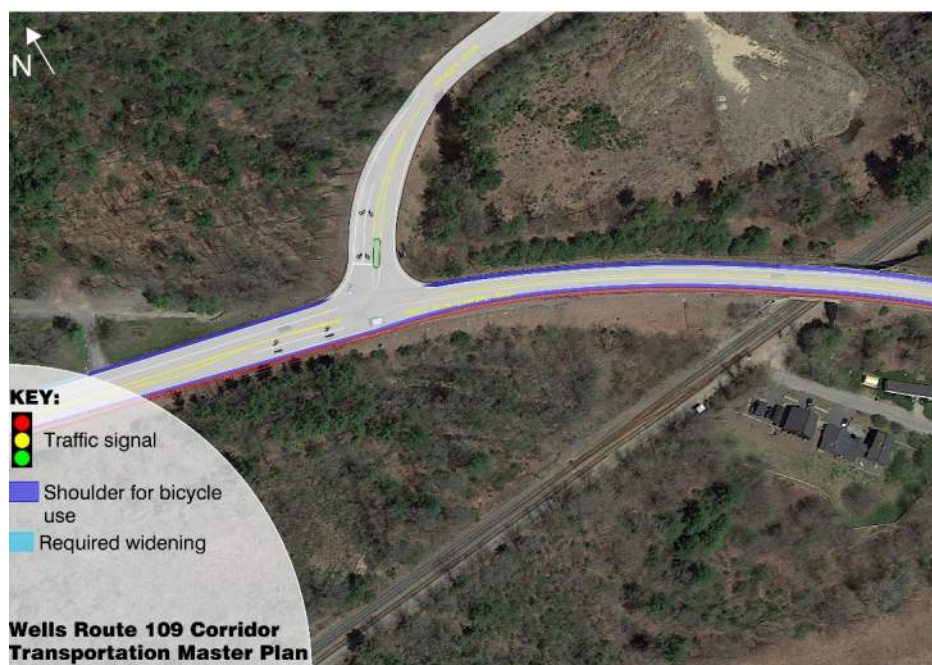
This intersection should be re-evaluated as future development occurs. At that time, several recommendations have been made for potential improvements to this intersection, as shown in **Figure 40**. These recommendations include:

- Formalize left turn bay eastbound (approximately 140 feet would be required to meet 2036 95<sup>th</sup> percentile queue estimates)
- Separate left and right lanes on Spencer Drive
- Modify island on Spencer Drive

**FIGURE 40: RECOMMENDED IMPROVEMENTS FOR THE INTERSECTION OF ROUTE 109 AND 9 AND SPENCER DRIVE**

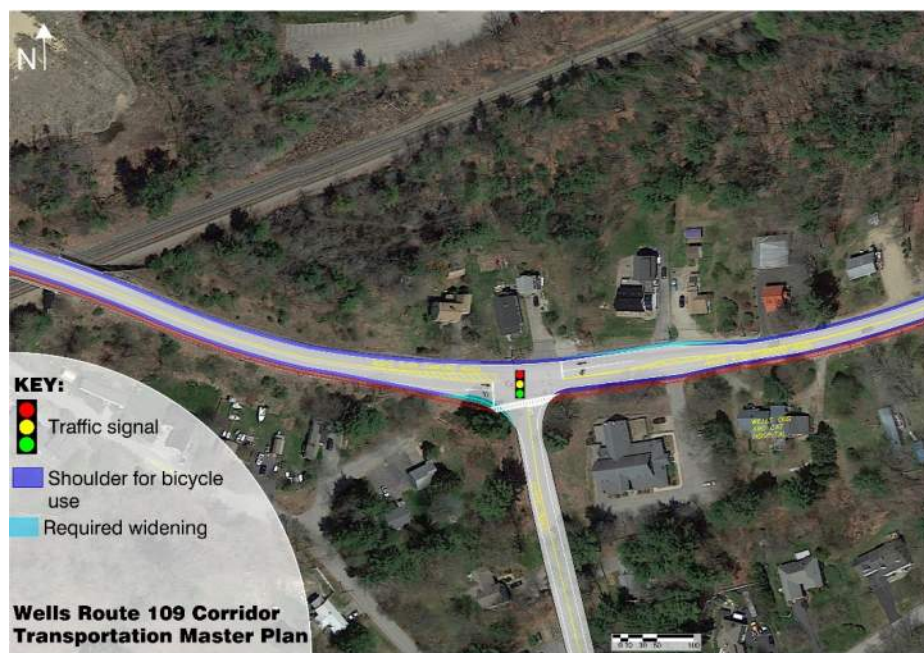
Several recommendations have been made for this intersection, as shown in **Figure 41**. These recommendations include:

- Modify the permissive signal phase for westbound left-turn movements to protected-permissive and extend the turn bay 50 feet to meet anticipated 2036 storage requirements. Adjustment to the existing traffic signal will be required.
- Widen the eastbound approach to accommodate a right turn area for vehicles turning onto Chapel Road and bike provisions

**FIGURE 41: RECOMMENDED IMPROVEMENTS FOR THE INTERSECTION OF ROUTES 109 AND 9 AND CHAPEL ROAD**

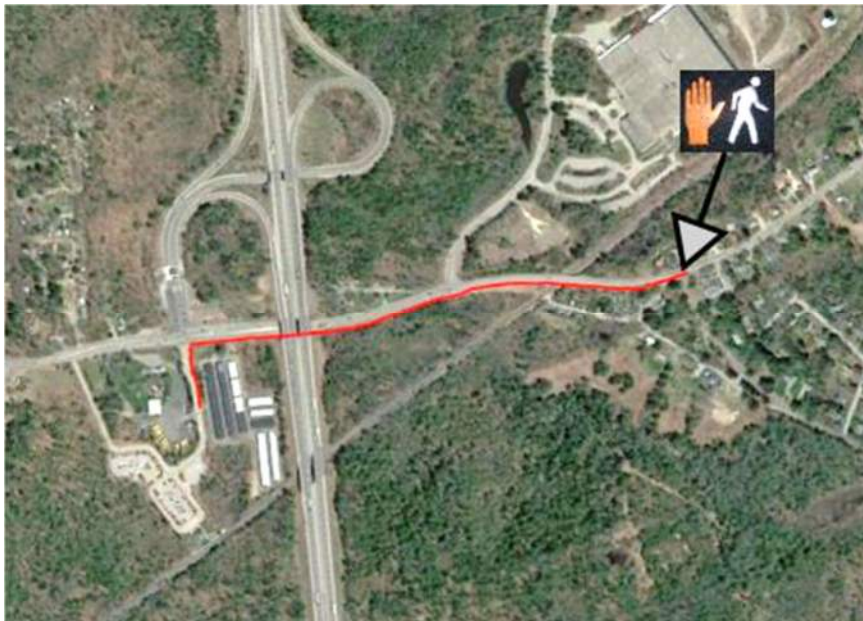
There are currently no pedestrian facilities in the corridor. It is suggested that the recommendations contained in the Wells Sidewalk Plan be considered and thus a sidewalk should be constructed on the south side of Route 109 from the terminus of the existing sidewalk (near the elementary school) to the Transportation Center. In conjunction with this, the traffic signal at Chapel Road will need to be upgraded for a new crosswalk with pedestrian heads and push buttons. The railroad bridge will need to be reconfigured roughly to consist of two 12 foot lanes, two 5.5 foot shoulders and a 5 foot sidewalk. According to a review by MaineDOT staff, this bridge can accommodate the additional pedestrian/sidewalk load. Finally, a sidewalk into the Transportation Center will be required. Please see the Appendix for full plans.
